NOTICE OF LAND USE RESTRICTIONS
(“[Add Property Name]”)

EXHIBIT A – PROTECTED MITIGATION AREA

EXHIBIT B – COMPENSATORY MITIGATION PLAN

LOCKELAND SPRINGS
STREAM RESTORATION PROJECT
DAVIDSON COUNTY, TENNESSEE

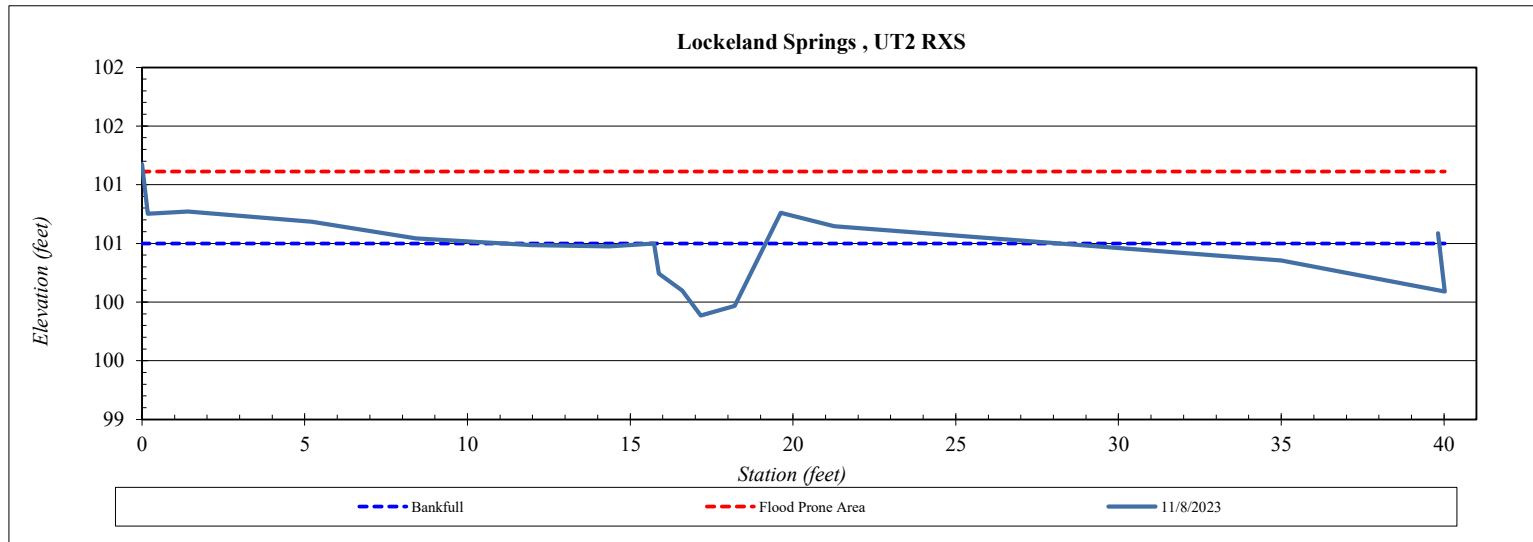
River Basin:	Lower Cumberland-Sycamore
Site:	Lockeland Springs
XS ID	UT2 RXS
Drainage Area (sq mi):	0.06
Date:	11/8/2023
Field Crew:	J. Sitz, T. Guess, E. White

SUMMARY DATA	
Bankfull Elevation:	100.50
Bankfull Cross-Sectional Area:	1.4
Bankfull Width:	3.3
Flood Prone Area Elevation:	101.1
Flood Prone Width:	39.8
Max Depth at Bankfull:	0.6
Mean Depth at Bankfull:	0.4
W / D Ratio:	7.8
Entrenchment Ratio:	12.2
Bank Height Ratio:	1.0

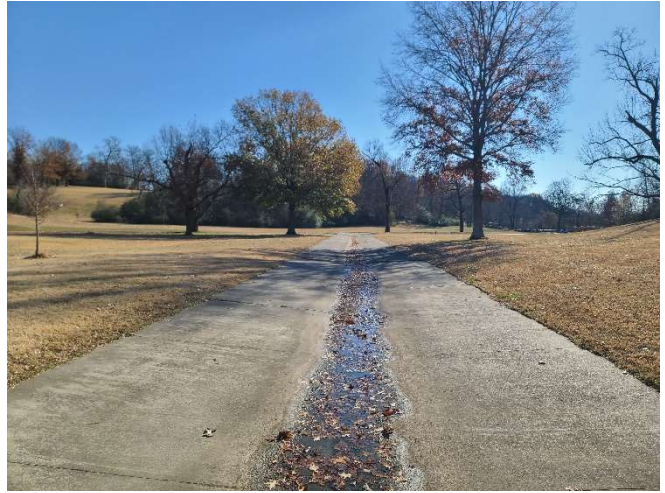
PRP 1 - Looking Upstream at beginning of UT1 Reach 1

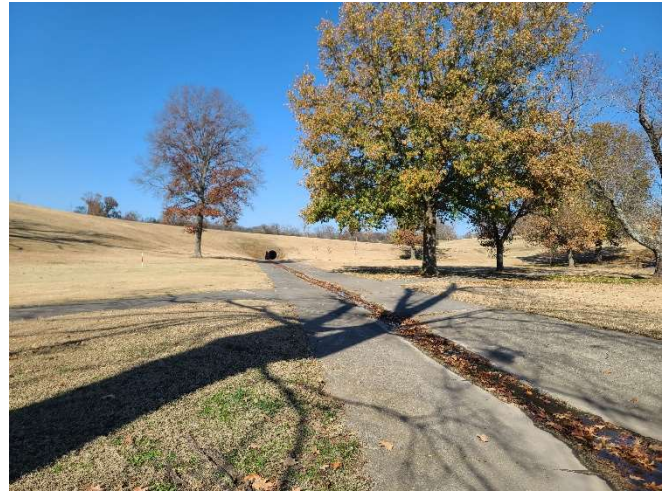
PRP 2 - Looking Upstream at oversized concrete channel on UT1 Reach 1

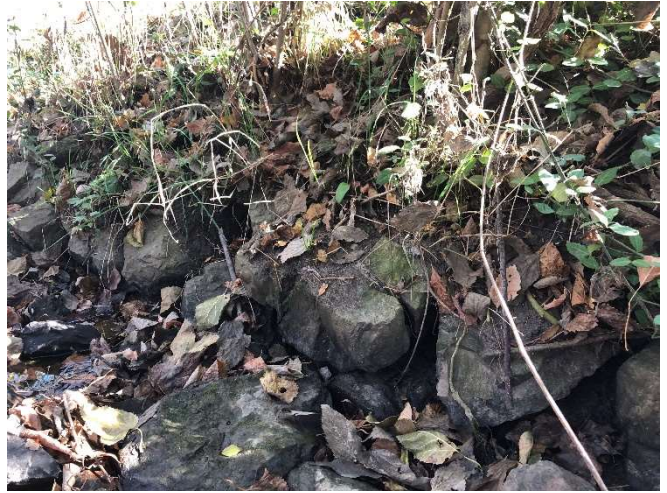
PRP 5 – Looking Downstream at Chinese privet-lined UT1 Reach 2

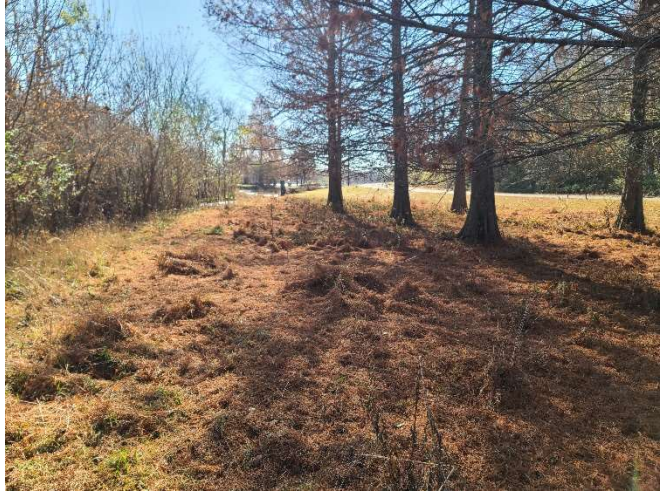
PRP 7 – Looking Downstream on UT2

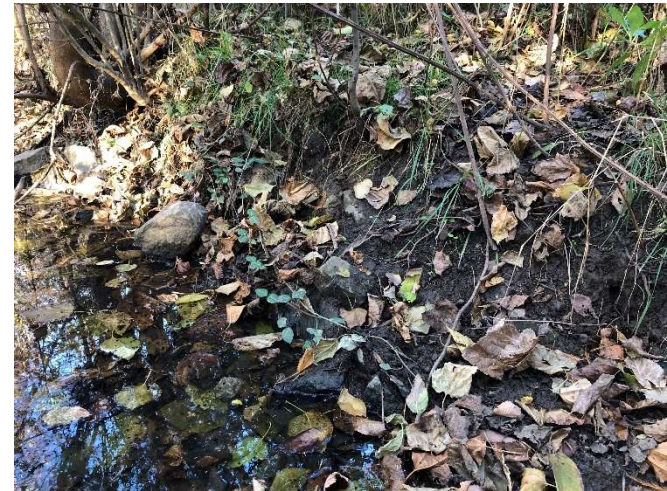
PRP 9 – Looking Downstream on UT1 Reach 2 showing stream buffer
