RE: Triune Residuals Management, LLC
Solid Waste Processing Permit Application
Permit-By-Rule Jackson Law Package
Triune Centennial Processing Facility

Triune Centennial
Processing Facility
Jackson Law Permit By Rule
Notification Package

7133 Centennial Boulevard, Nashville, TN

Prepared For: Triune Residuals Management, LLC

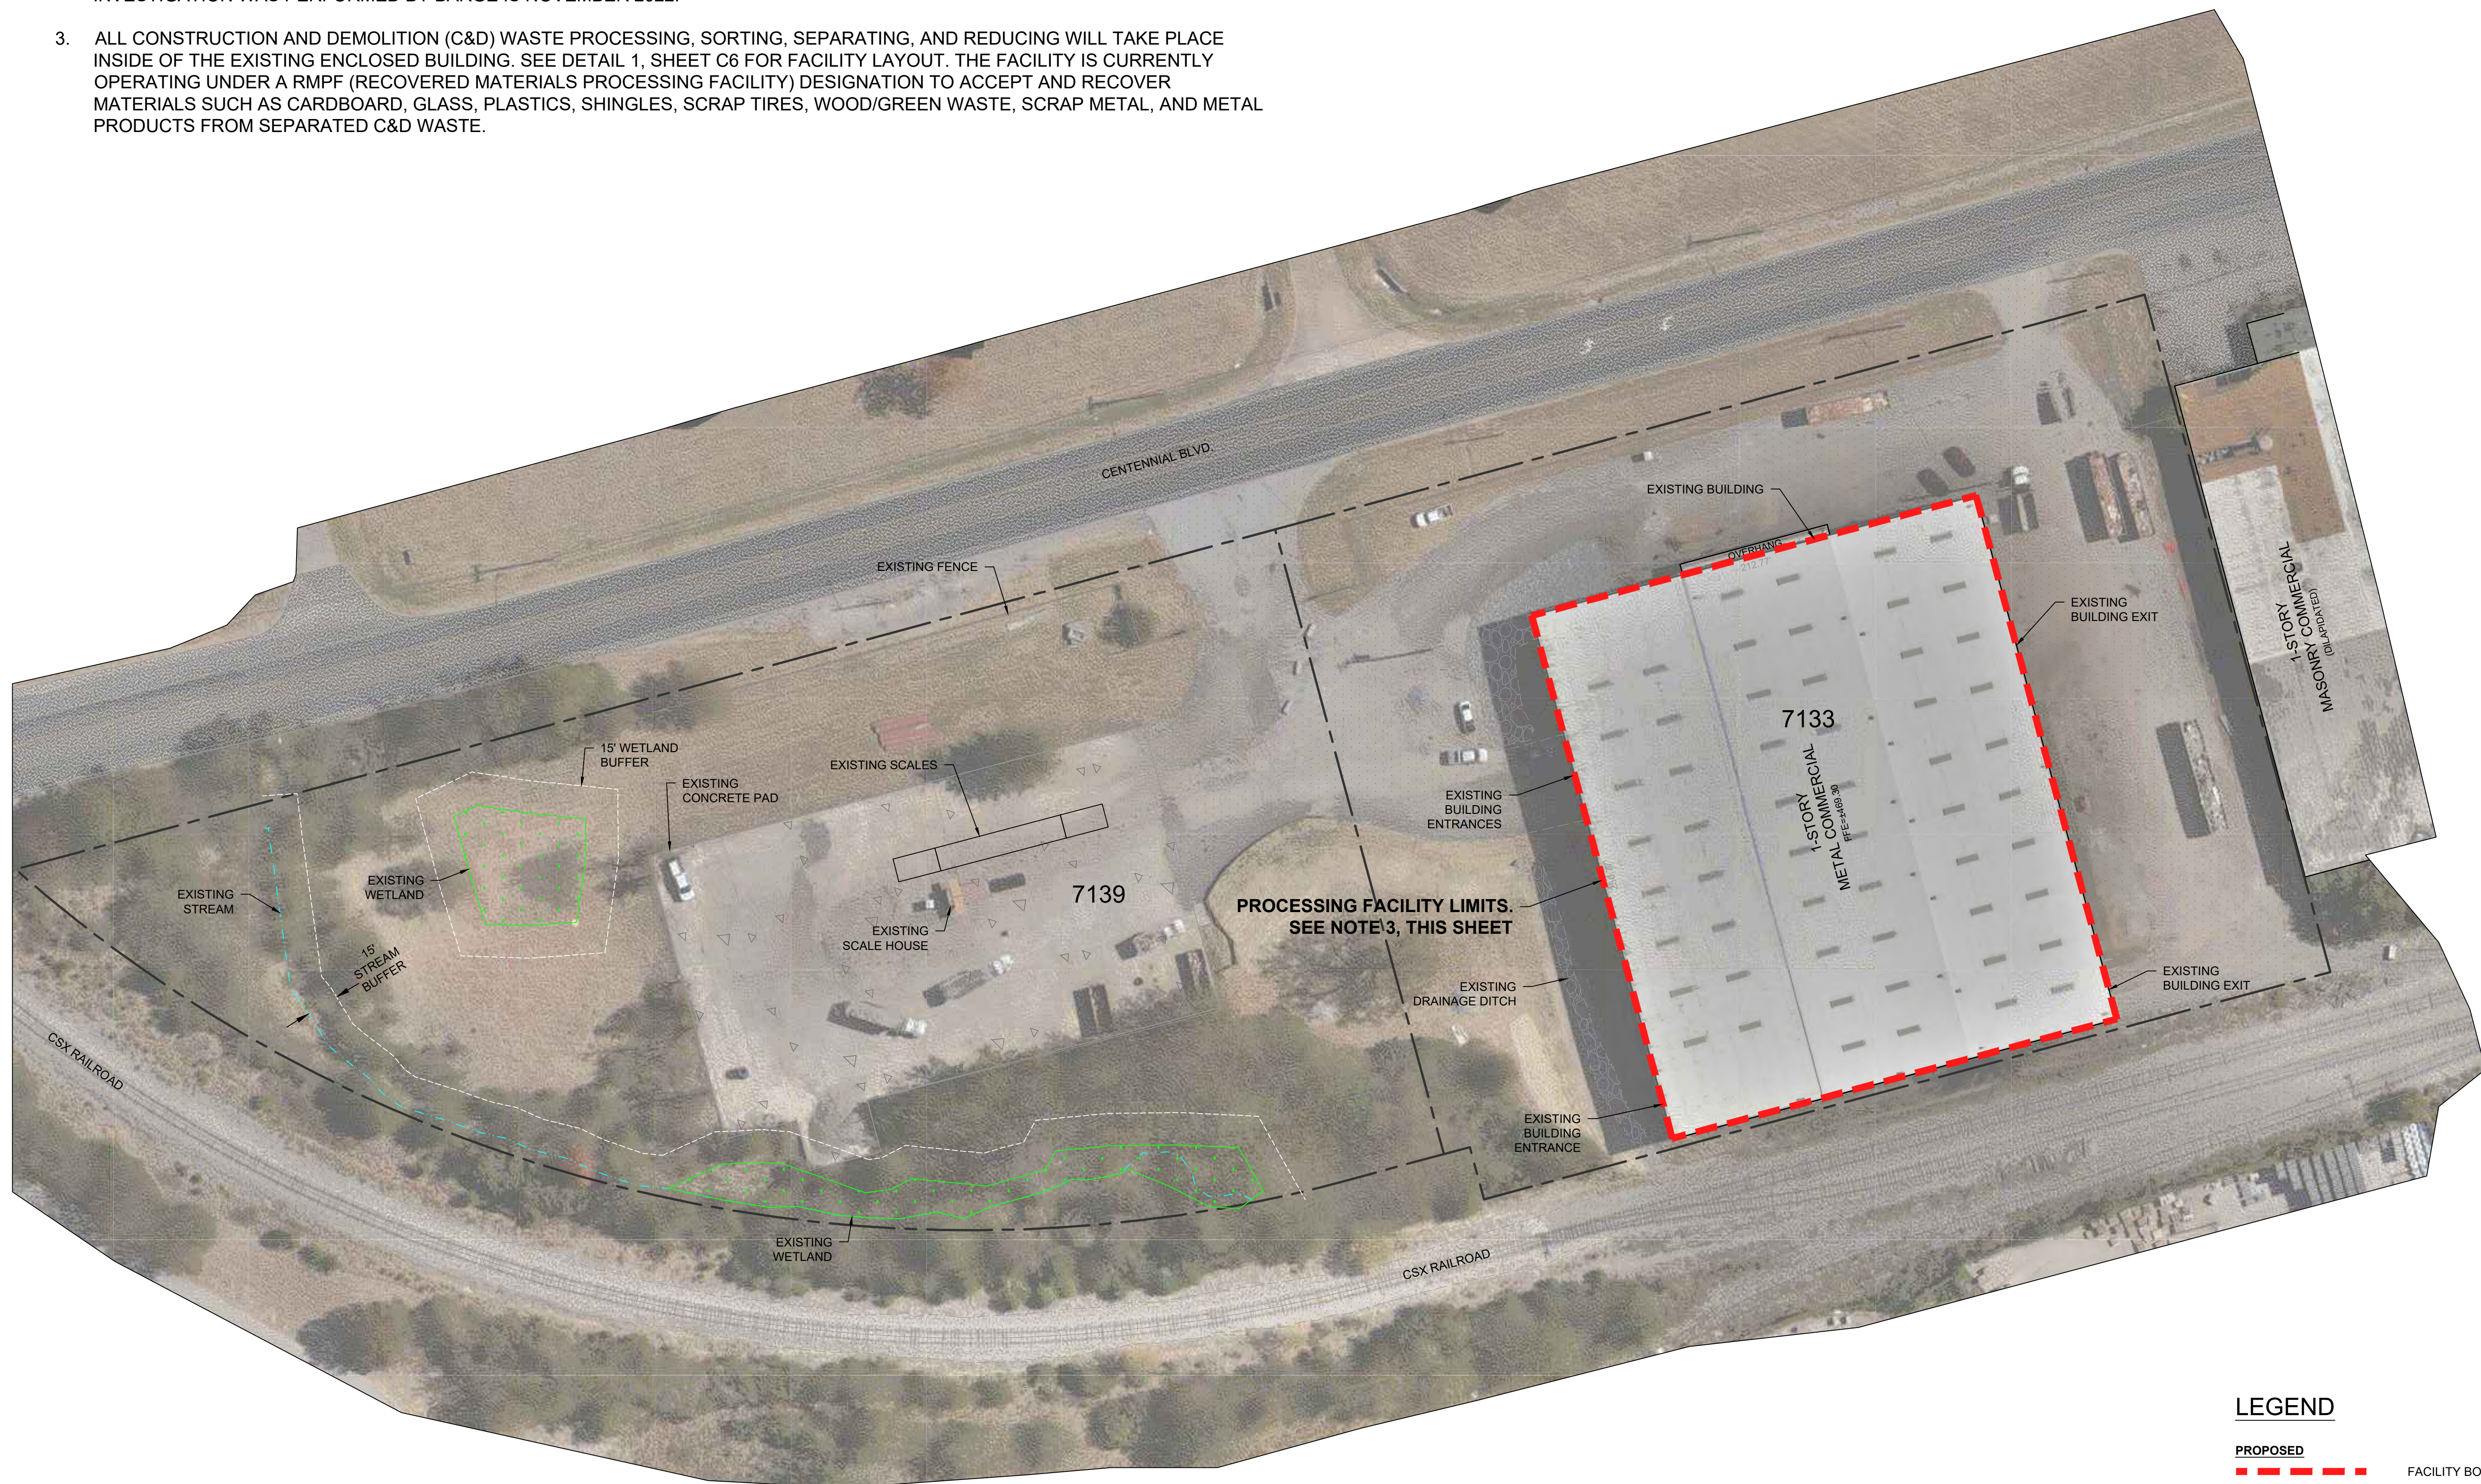
- 1. PROPERTY BOUNDARIES ARE SHOWN FOR REFERENCE PURPOSES ONLY AND ARE BASED ON METRO PARCEL VIEWER.
- 2. AERIAL IMAGERY SHOWN IS FROM AN AERIAL SURVEY PERFORMED BY BARGE OCTOBER 2022. ENVIRONMENTAL SITE INVESTIGATION WAS PERFORMED BY BARGE IS NOVEMBER 2022.
- 3. ALL CONSTRUCTION AND DEMOLITION (C&D) WASTE PROCESSING, SORTING, SEPARATING, AND REDUCING WILL TAKE PLACE INSIDE OF THE EXISTING ENCLOSED BUILDING. SEE DETAIL 1, SHEET C6 FOR FACILITY LAYOUT. THE FACILITY IS CURRENTLY OPERATING UNDER A RMPF (RECOVERED MATERIALS PROCESSING FACILITY) DESIGNATION TO ACCEPT AND RECOVER MATERIALS SUCH AS CARDBOARD, GLASS, PLASTICS, SHINGLES, SCRAP TIRES, WOOD/GREEN WASTE, SCRAP METAL, AND METAL PRODUCTS FROM SEPARATED C&D WASTE.

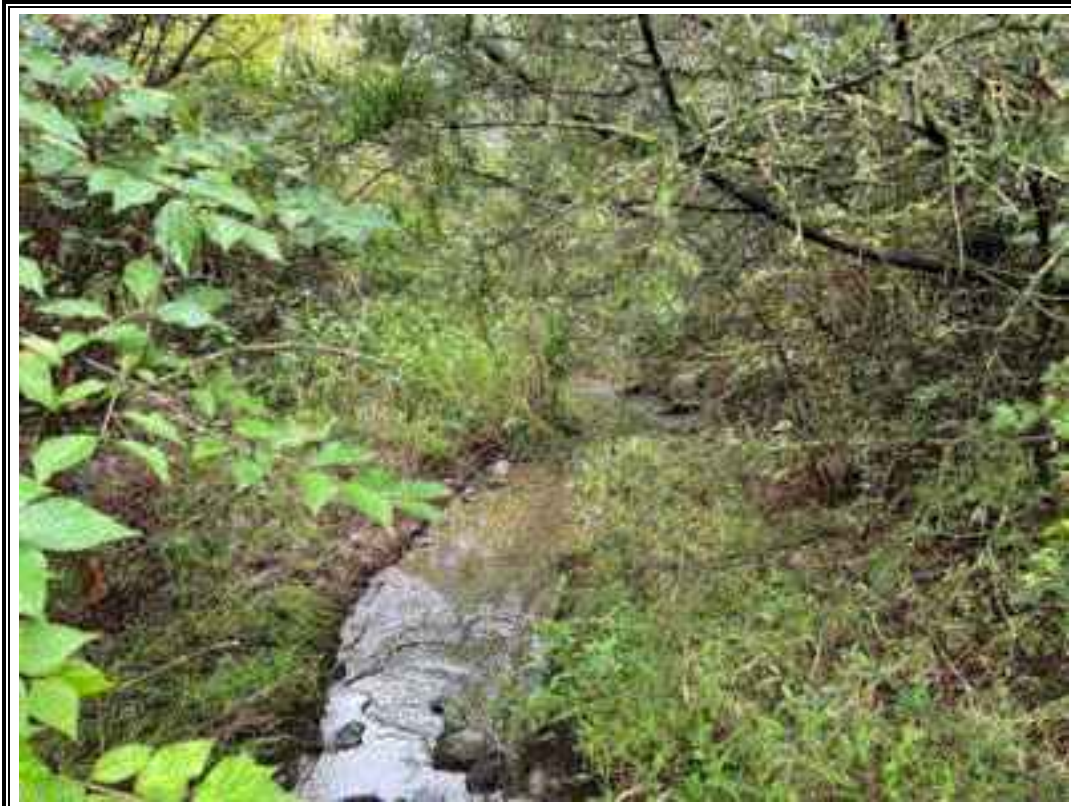
Photo: 1
By: F. Amatucci
Date: August 11, 2022
Feature: STR-1
Lat: 36.183201
Long: -86.878535

Representative conditions of STR-1 at the start of the reach.

STR-1 was observed as an intermittent stream along the northern and western limits of the project study area. The delineated stream was observed with a moderate presence of baseflow, which traversed to the southwest into wetland (WTL) WTL-1, where the defined channel of the stream continues offsite to the southwest. Bed and bank upslope of WTL-1 is moderately present throughout the inspected reach, as well as Ordinary High-Water Mark (OHWM) indicators. STR-1 had as channel bottom composed of bedrock, cobble, and sand. STR-1 is assumed to be jurisdictional to TDEC and the USACE.

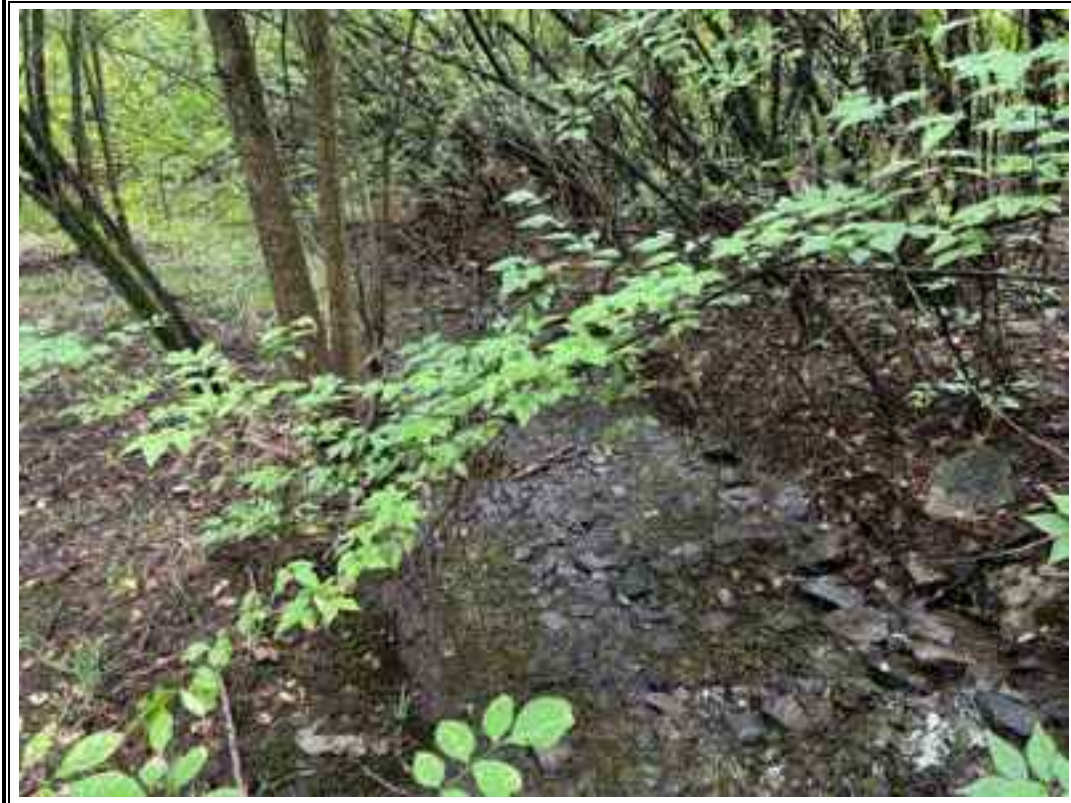
Photo: 2
By: F. Amatucci
Date: August 11, 2022
Feature: STR-1
Lat: 36.182776
Long: -86.878785

Representative conditions of STR-1 before a slight loss of bed and bank within WTL-1.

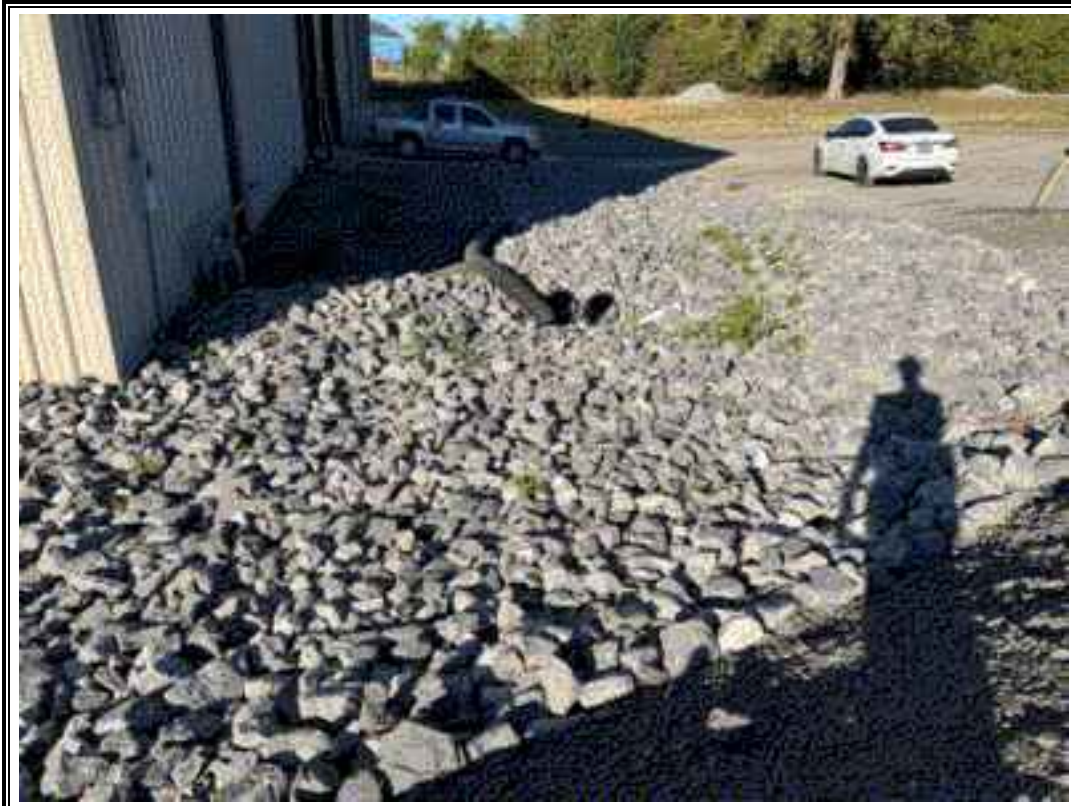
Photo: 3
By: F. Amatucci
Date: August 11, 2022
Feature: SWD-1
Lat: 36.181705
Long: -86.877865

Representative conditions of SWD-1 adjacent to the warehouse structure.

SWD-1 was observed as a man-made drainage swale north of the existing warehouse structure within the project study area. The man-made drainage swale originates from a stormwater grate at the entrance of the building and is conveyed to the west along the northside of the warehouse to the offsite downstream portion of STR-1. SWD-1 was observed with no visible indication of channel formation and was entirely rip-rapped within the project study area. SWD-1 is assumed to be non-jurisdictional to TDEC as a wet weather conveyance and to the USACE.

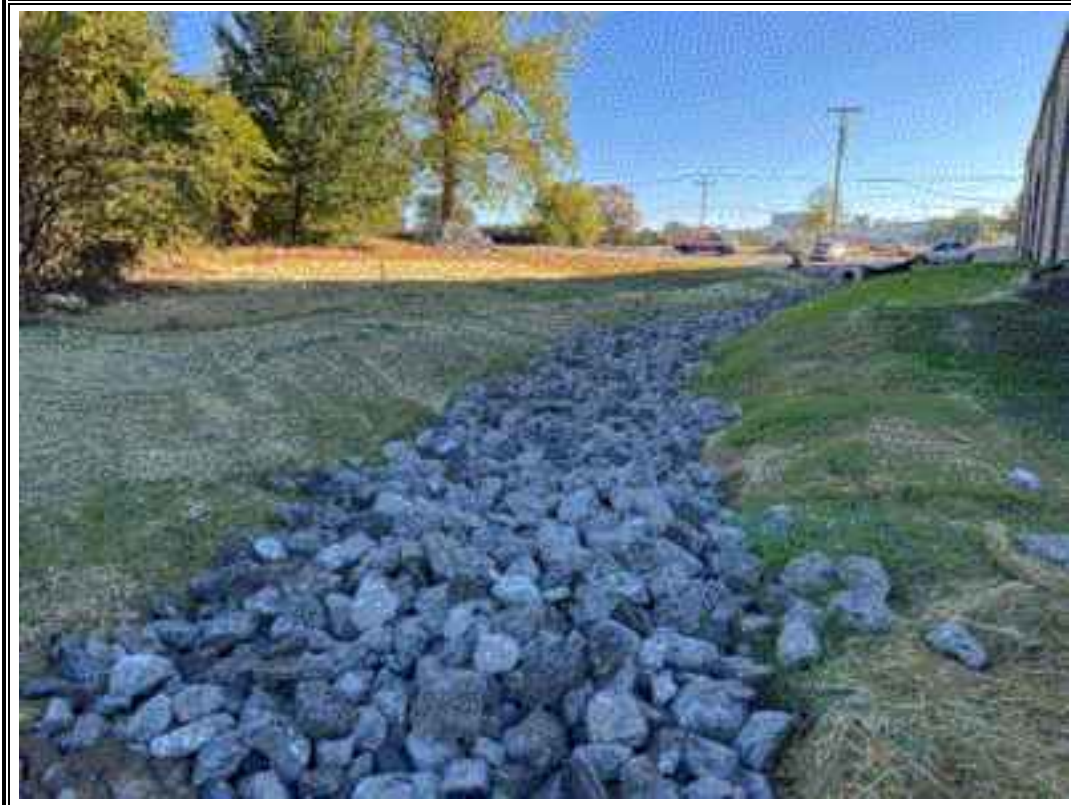
Photo: 4
By: F. Amatucci
Date: August 11, 2022
Feature: SWD-1
Lat: 36.181531
Long: -86.878712

Representative conditions of SWD-1 prior to flowing offsite behind the warehouse structure.

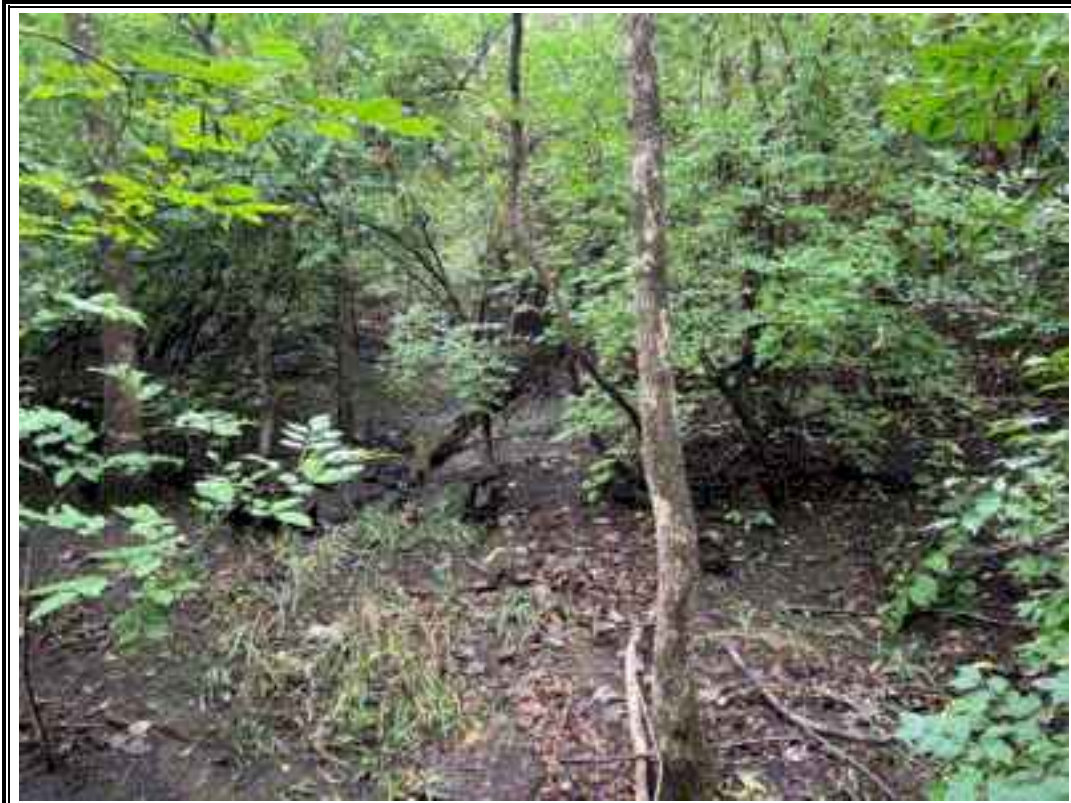
Photo: 5
By: F. Amatucci
Date: August 11, 2022
Feature: WTL-1
Lat: 36.182088
Long: -86.878748

Representative conditions of WTL-1 serving as a floodplain for STR-1.

WTL-1 was observed as a floodplain PFO wetland along the stream valley of STR-1 in the western portion of the project study area. The floodplain wetland is situated at the downslope portion of STR-1, where bed and bank begin to weaken. All excess surface water drains back into STR-1 at the western limit of the project study area and potential other Waters of the United States (WOTUS). WTL-1 was observed with a presence of saturation, a perched water table, and water-stained leaves, indicating positive wetland hydrology. The wetland was observed with a dominance of hydrophytic vegetation such as green ash (*Fraxinus pensylvanica*) in the tree and sapling stratum; and fowl mannagrass (*Glyceria striata*) and clear wed (*Pilea pumila*) in the herbaceous stratum. Hydric soils were also documented in WTL-1, which were observed with a shallow dark layer underlain by depleted hydric soils with a presence of redoximorphic concentrations. Due to the potential connection to other WOTUS, WTL-1 is assumed to be jurisdictional to TDEC and the USACE.

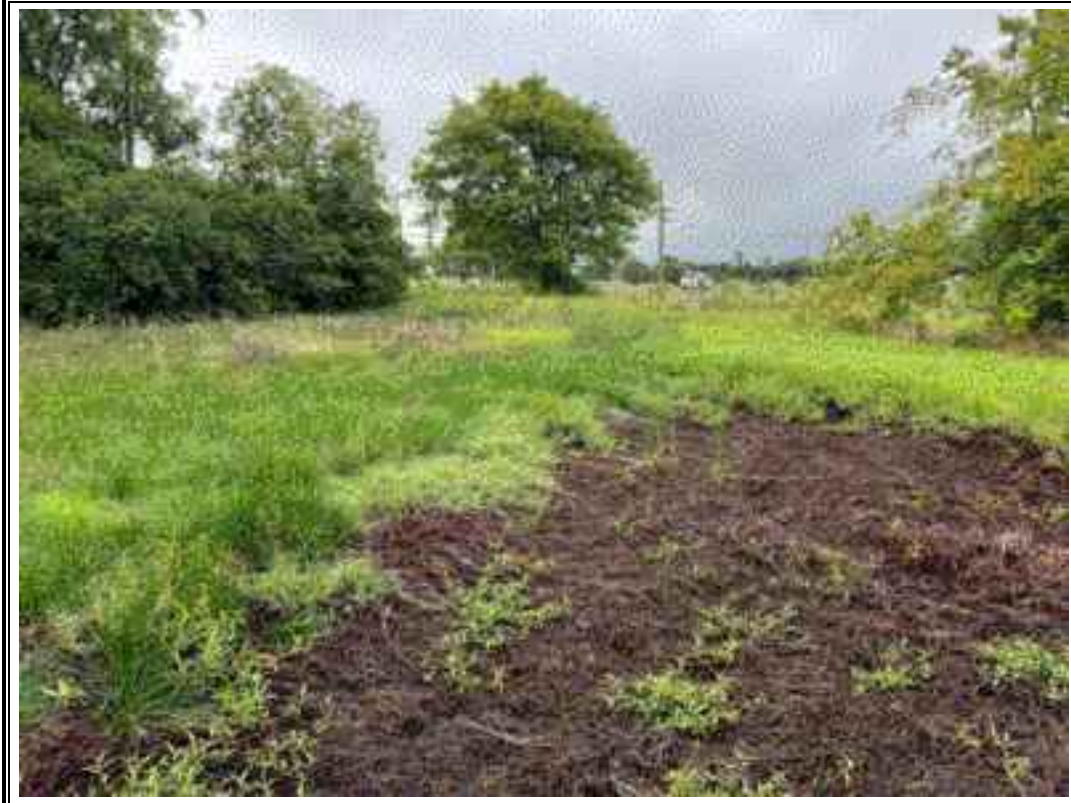
Photo: 6
By: F. Amatucci
Date: August 11, 2022
Feature: WTL-2
Lat: 36.182924
Long: -86.878282

Representative conditions of depressional wetland WTL-2.

WTL-2 was observed as a PEM depressional wetland in the northern portion of the project study area. The wetland is likely a man-made depressional feature on top of shallow bedrock. No observable outfall, inlet, or surface water connection to other water resources was determined. Therefore, WTL-2 was determined to be isolated from other WOTUS. WTL-2 was observed with a presence of saturation and water-stained leaves, indicating positive wetland hydrology. The wetland was observed with a dominance of hydrophytic vegetation such as fox sedge (*Carex vulpinoidea*), nut sedge (*Cyperus esculentus*), and pepper weed (*Persicaria hydropiper*) in the herbaceous stratum. Shallow hydric soils were also documented in WTL-2, which were observed with a thin dark layer underlain by depleted hydric soils on top of shallow bedrock. Due to the lack of observable connection to other WOTUS, WTL-2 is assumed to be isolated and non-jurisdictional to the USACE and only jurisdictional to TDEC.

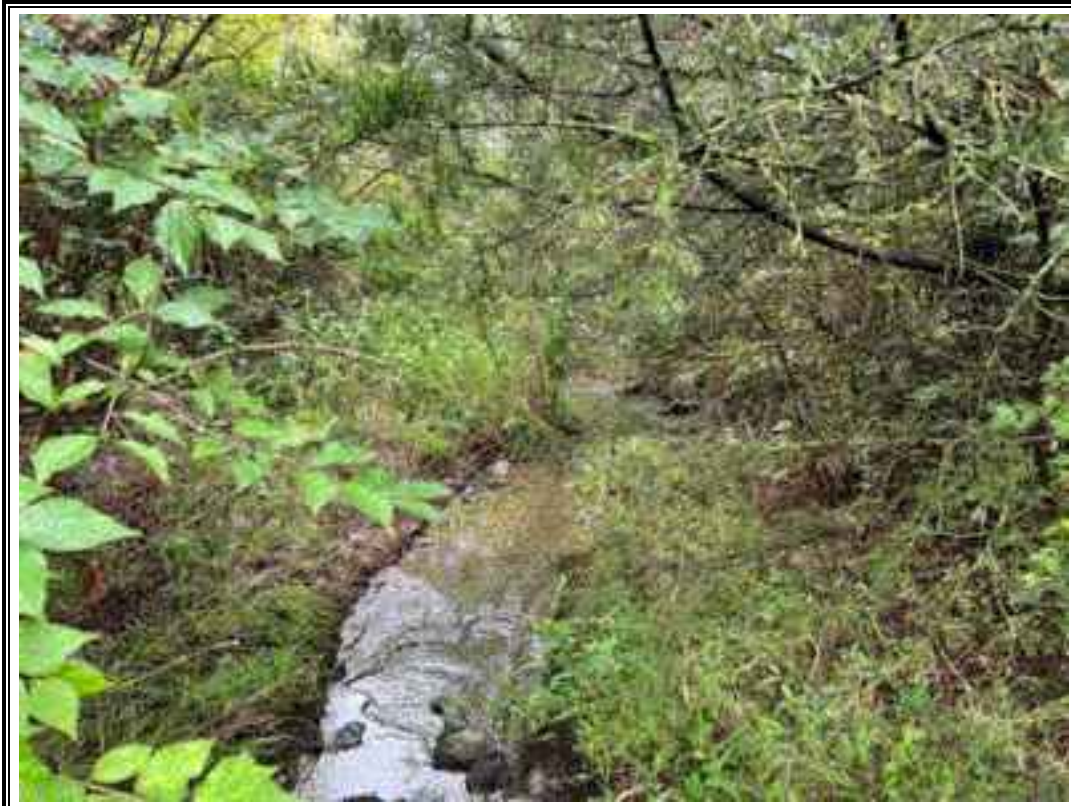
Photo: 1
By: F. Amatucci
Date: August 11, 2022
Feature: STR-1
Lat: 36.183201
Long: -86.878535

Representative conditions of STR-1 at the start of the reach.

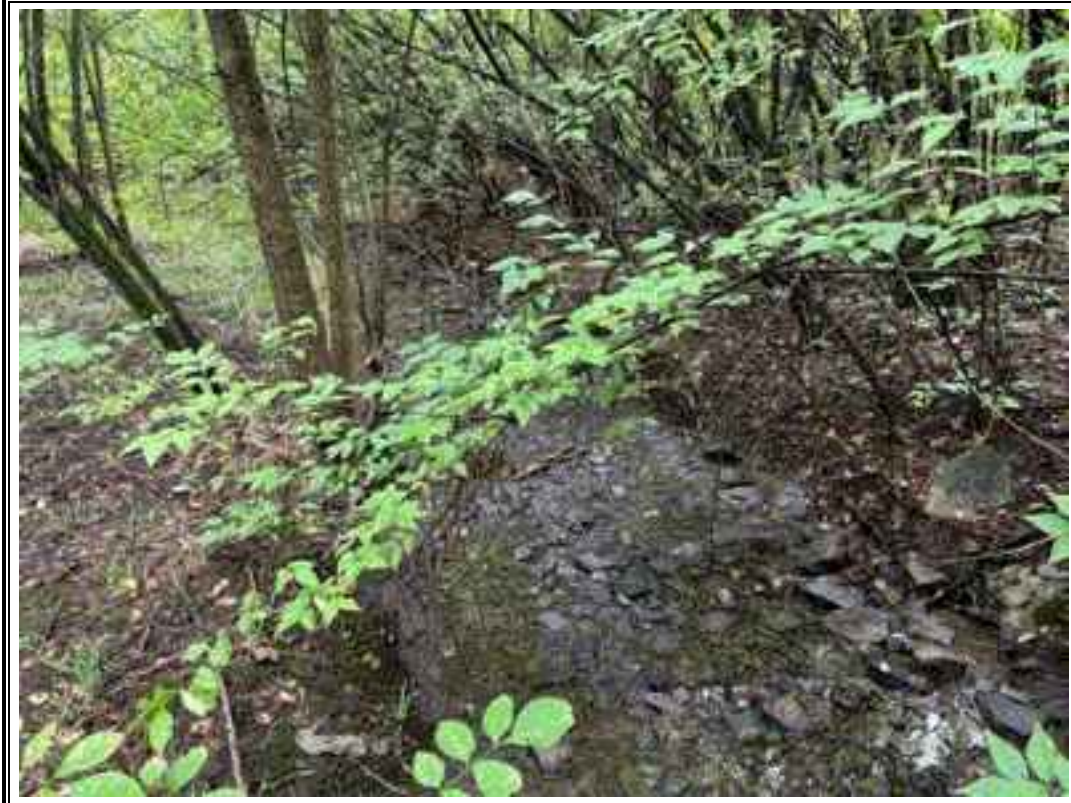
Photo: 2
By: F. Amatucci
Date: August 11, 2022
Feature: STR-1
Lat: 36.182776
Long: -86.878785

Representative conditions of STR-1 before a slight loss of bed and bank within WTL-1.

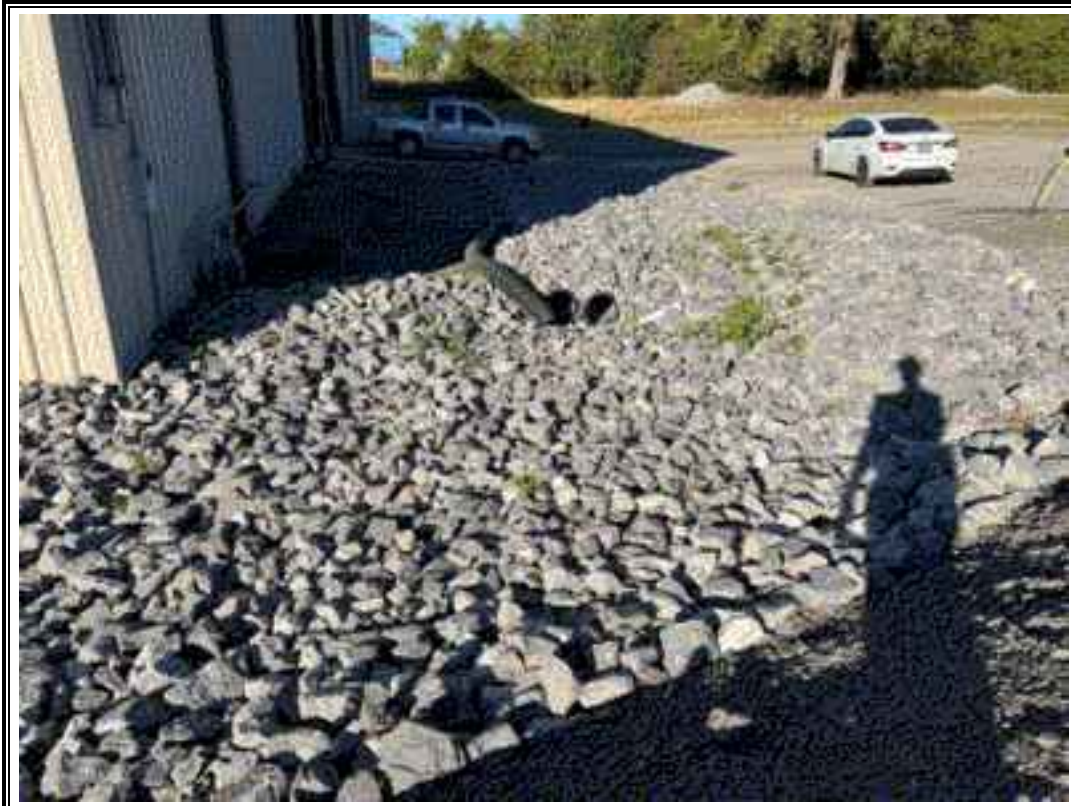
Photo: 3
By: F. Amatucci
Date: August 11, 2022
Feature: SWD-1
Lat: 36.181705
Long: -86.877865

Representative conditions of SWD-1 adjacent to the warehouse structure.

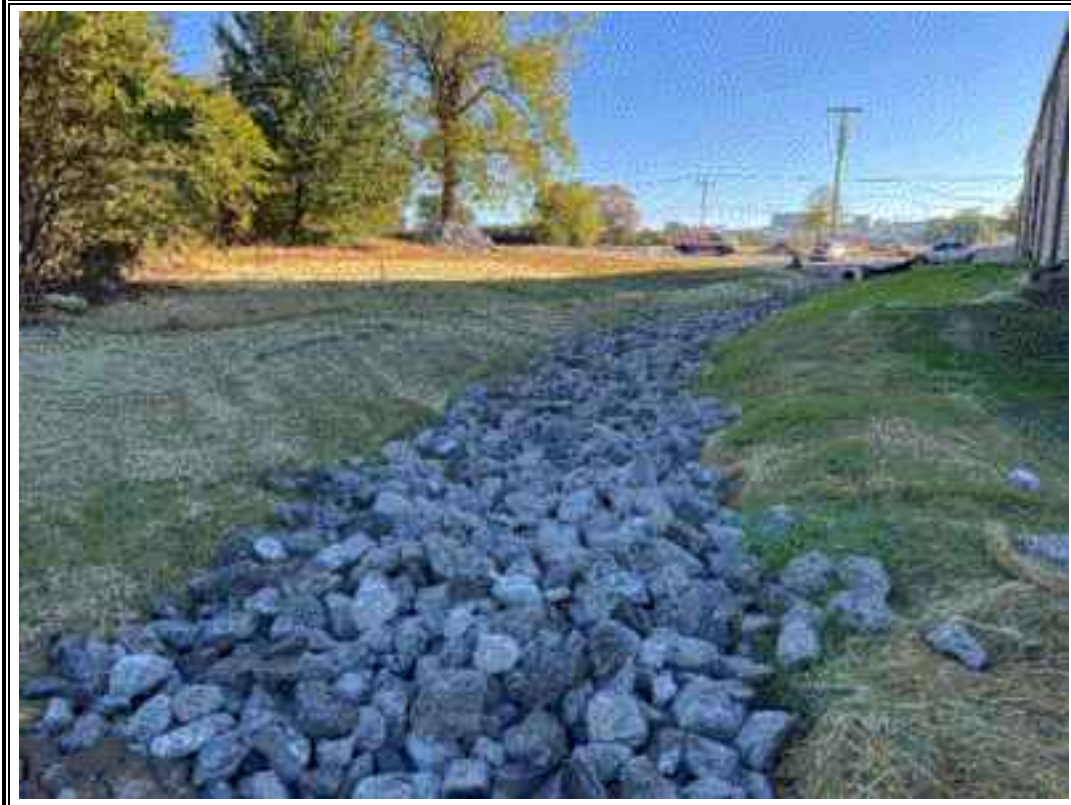
Photo: 4
By: F. Amatucci
Date: August 11, 2022
Feature: SWD-1
Lat: 36.181531
Long: -86.878712

Representative conditions of SWD-1 prior to flowing offsite behind the warehouse structure.

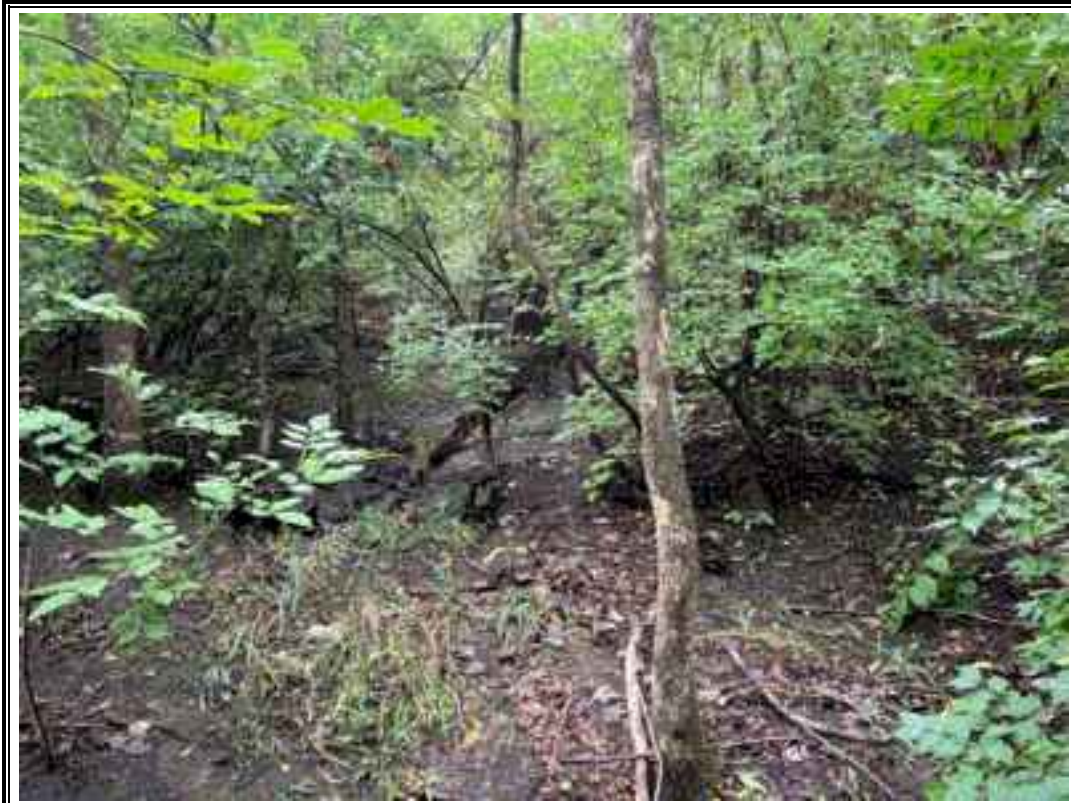
Photo: 5
By: F. Amatucci
Date: August 11, 2022
Feature: WTL-1
Lat: 36.182088
Long: -86.878748

Representative conditions of WTL-1 serving as a floodplain for STR-1.

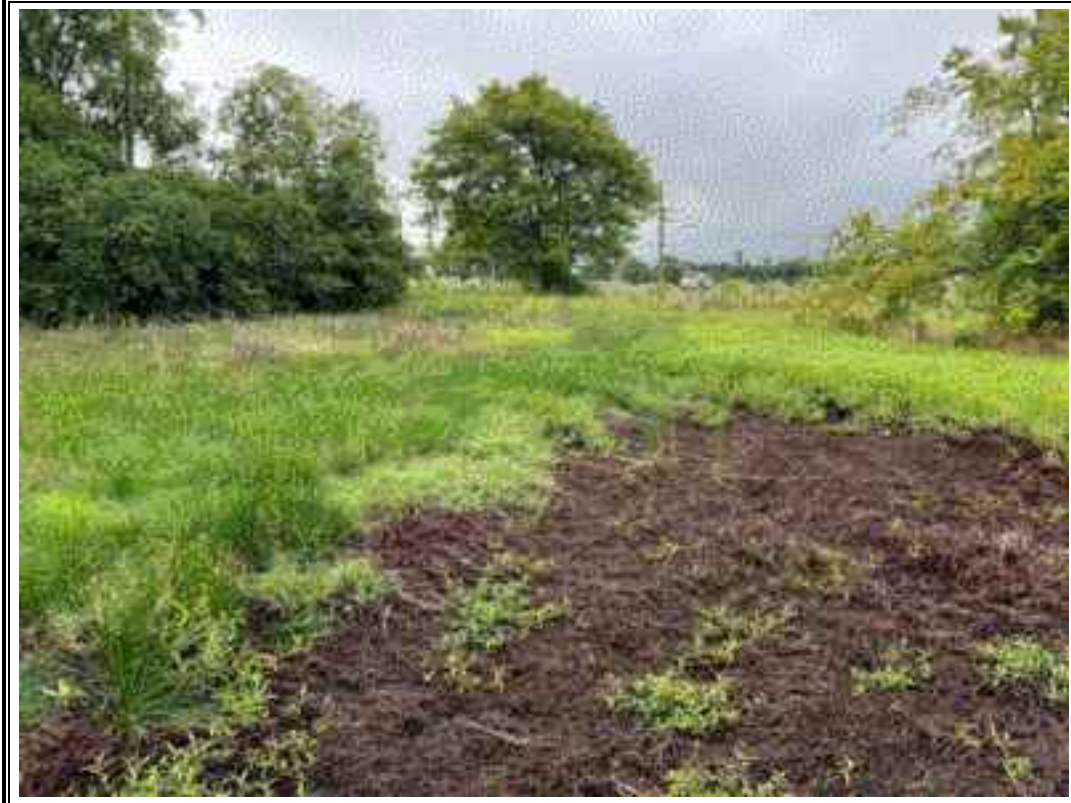
Photo: 6
By: F. Amatucci
Date: August 11, 2022
Feature: WTL-2
Lat: 36.182924
Long: -86.878282

Representative conditions of depressional wetland WTL-2.

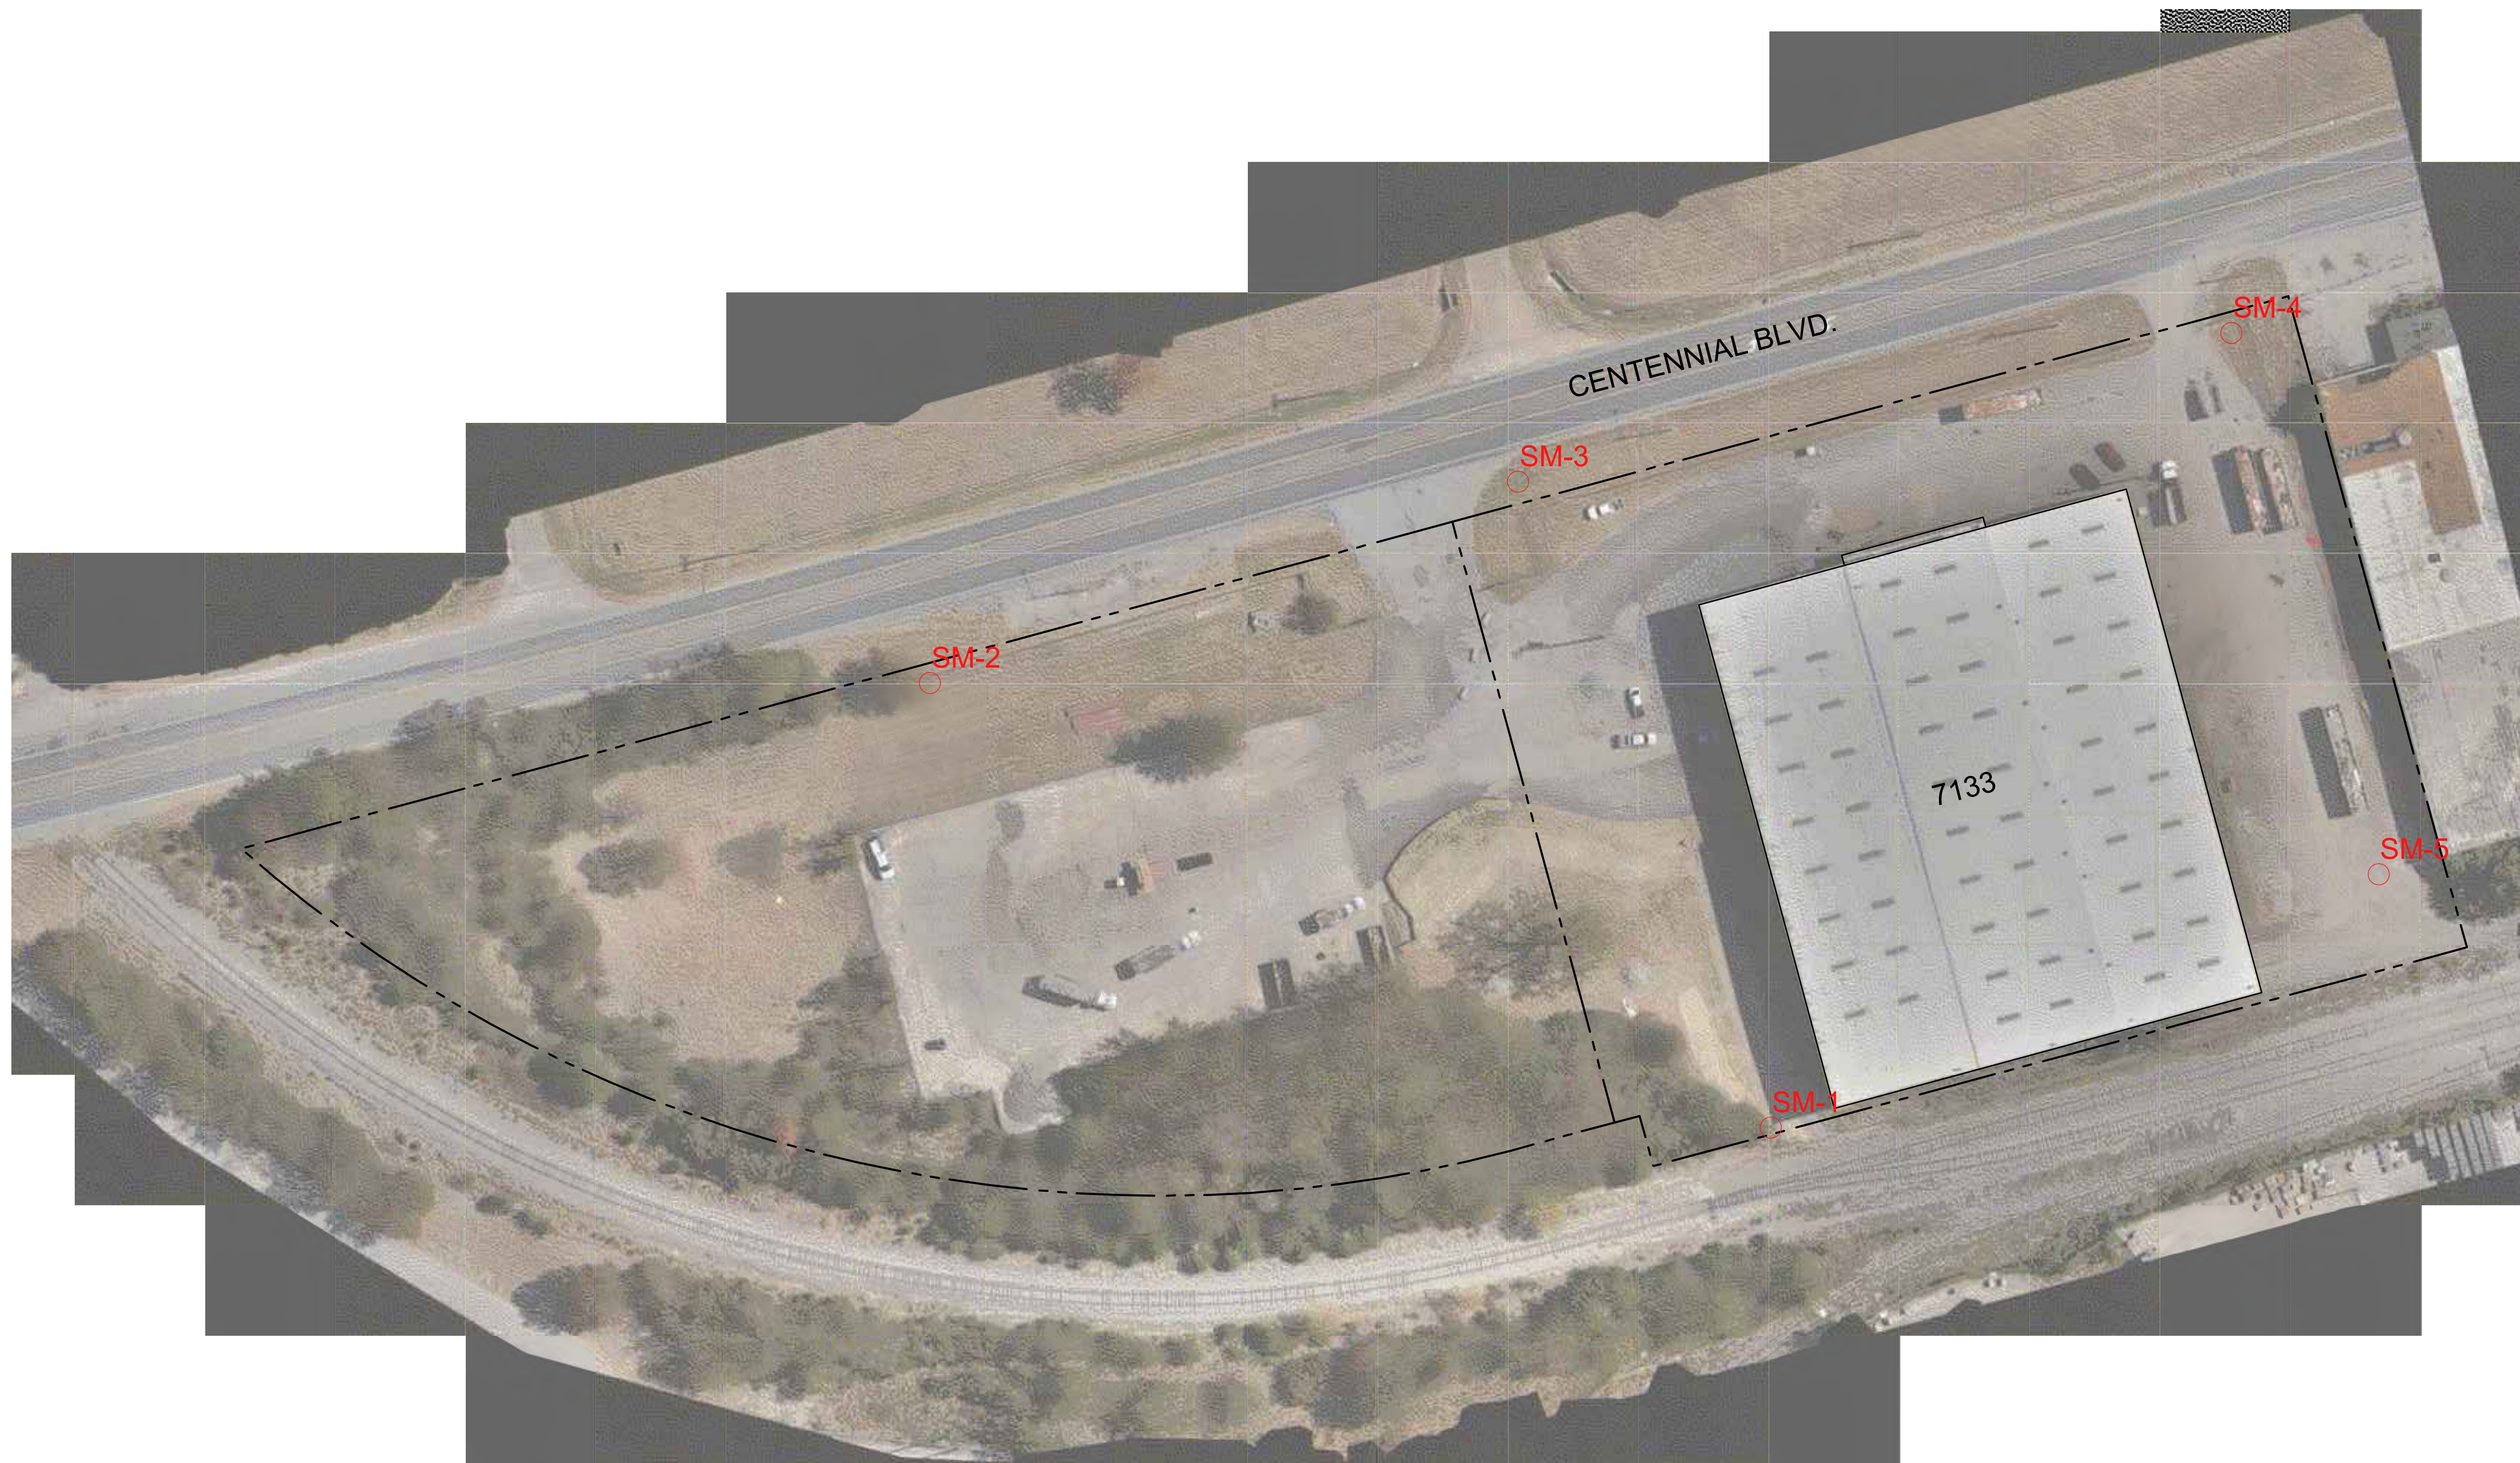
Noise Level of Surrounding Property				
Location	Measurement Period (minutes)	Laeq (dB)	Lcpeak (dB)	Max Level (dB)
SM-1	5:01	62.2	104.8	76.7
SM-2	5:02	55.3	100.9	79
SM-3	5:02	63.2	111.4	84.2
SM-4	5:01	67.6	113.8	87.1
SM-5	5:01	61.2	113.5	89.9

1. NOISE SAMPLING SURVEY WAS PERFORMED BY BARGE IN DECEMBER 2022.

Max level is the maximum RMS (root mean square) sound level. The RMS is the essentially the "average" value of the pressure. **Max level** pressure measurements give a better picture of the general maximum noise level while **LCpeak** measurement gives the maximum pressure recorded during the sampling survey.
